# **Mir Photo/TV Survey (DTO-1118): STS-86 Mission Report**

Prepared by:  
**Image Science and Analysis Group**  
**Space Science Branch**  
**Earth Science and Solar System Exploration Division**

March 4, 1998

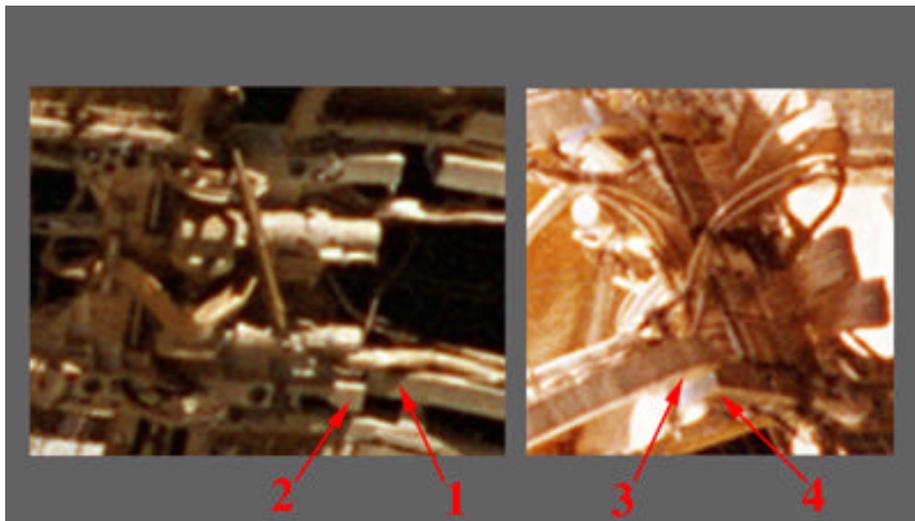
**Figure 3.9 Close-up of Spektr SP#1 Sheared Support Beam**

- The damage to Mir caused by the Progress collision appears limited to the surfaces and appendages of Spektr. The Spektr SP#1 received the greatest amount of damage, with sheared center support beams and a large hole through the array. SP#3 had a scrape mark and some bent supports. One radiator on the surface of the module was bent in the collision. The areas of damage are described in Section 3 and Appendix A.
-

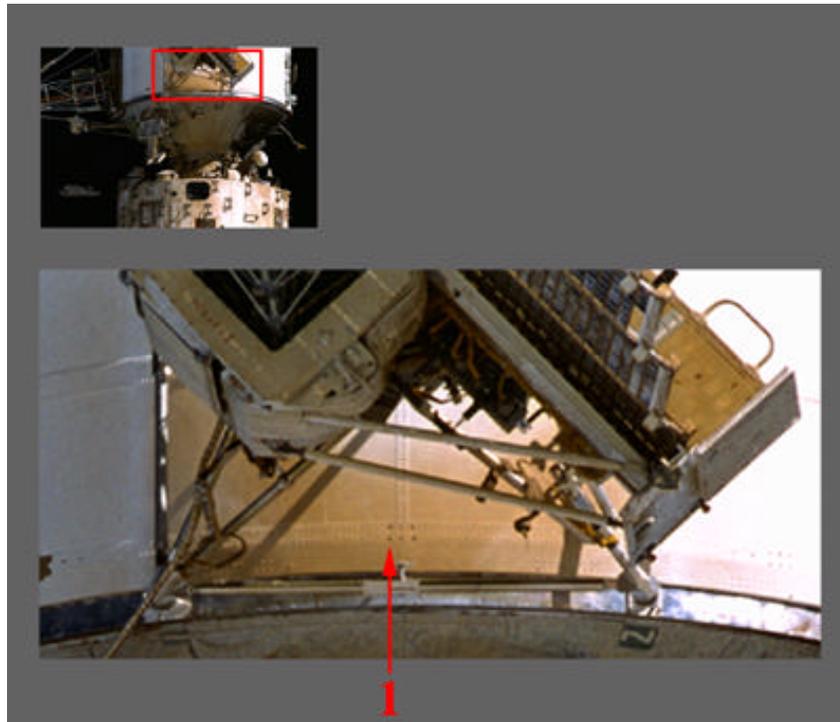
**Figure 3.13 Deposition on +ZB Kvant Radiator Surface**

Figure 3.13 is the highest resolution photograph to date of the +ZB SP#1 attach point on Kvant. The discoloration [1] seen on the Kvant radiator surface below the attach point appears similar to the discoloration seen in Figure 3.12. Like Figure 3.12 of the -ZB radiator surface, there also appears to be a preferential pattern to the deposition on the +ZB radiator surface. The heaviest deposition on this side appears to be occurring in the -XB, +YB direction away from the SP#1 attach point. Although the array is obscuring the view of the Kvant radiator surface, other photographs verify this preferential pattern of deposition as well. This deposition is not occurring in the same direction from the array attach as the deposition on the other side of the module.

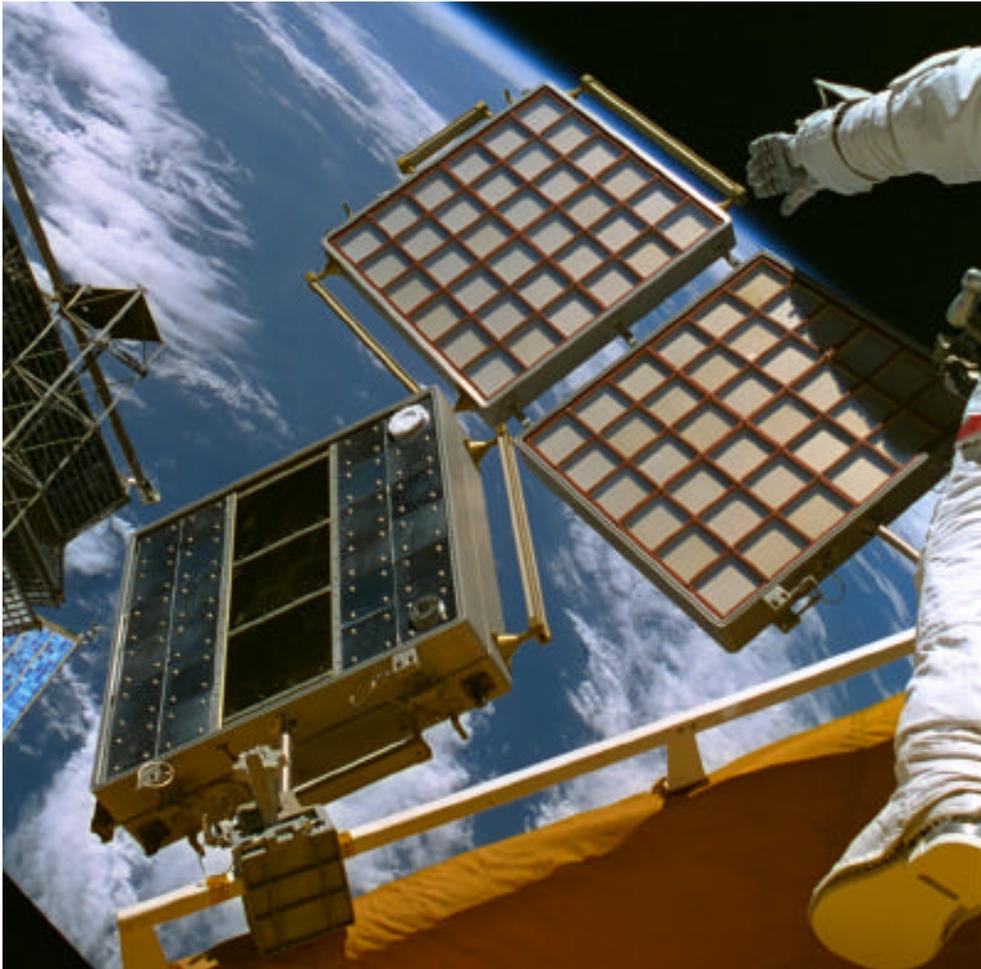
**Figure 7.2 EVA Image of PPMD (left) and ODC (right)**

Detailed, close-up images of the panels were taken with the 35 mm camera during the EVA to retrieve the four experiment payloads. Figure 7.2 shows the PPMD and ODC experiments to be in good condition. Figure 7.3 shows evidence of possible contamination of POSA II in the form of numerous small brown spots visible on the outer casing and on areas within the panel. Preliminary results of analysis of the MEEP panels presented at the ISS/Mir Space Environment Effects Meeting of January 13, 1998 suggest

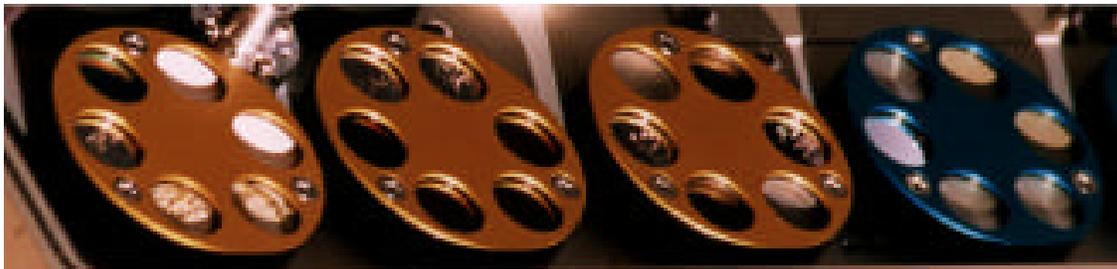
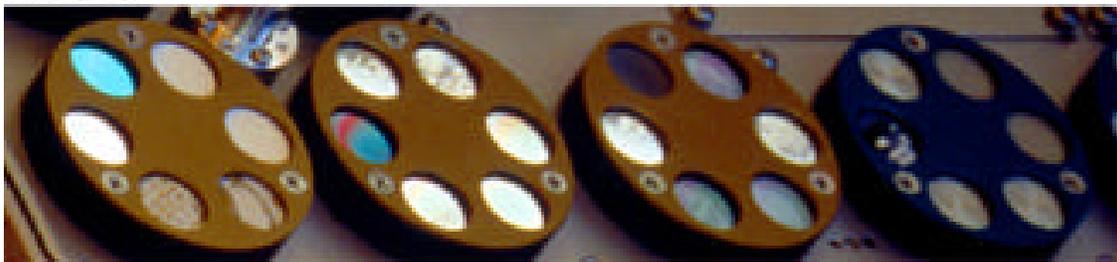
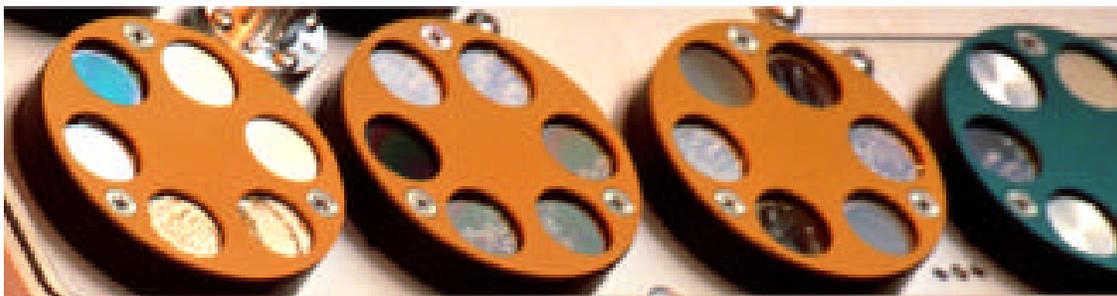
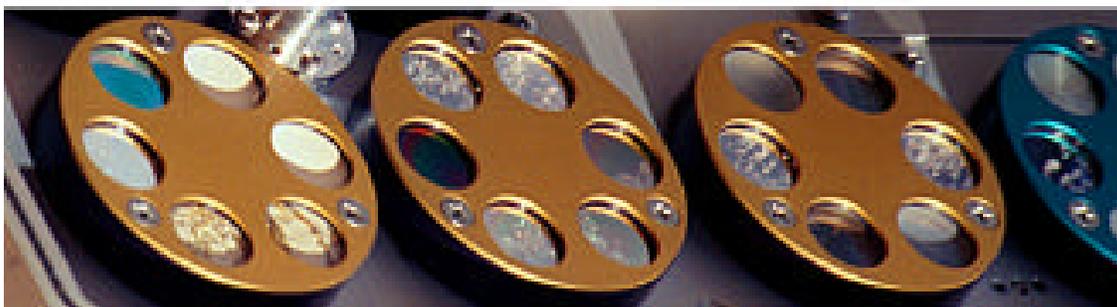
**Figure 7.4 Images of the Same Section of POSA Taken on Four Separate Shuttle/Mir Missions**

Images of the space-facing side of POSA taken from the aft flight deck window show what appear to be small white deposits on some of the circular, optical test specimens in the panel. The nature of these deposits is still under investigation. A review of the imagery of past missions shows that these deposits began appearing as early as the STS-79 mission. Figure 7.4 is a composite of images from missions STS-79 through STS-86, each showing an identical section of the POSA panel containing the deposits. All were taken from the aft flight deck window and all were taken with the 35 mm camera except for the STS-81 image which was taken with the 70 mm Hasselblad. The images in Figure 7.4 have been adjusted to a common scale to account for the varying focal length lenses that were used.

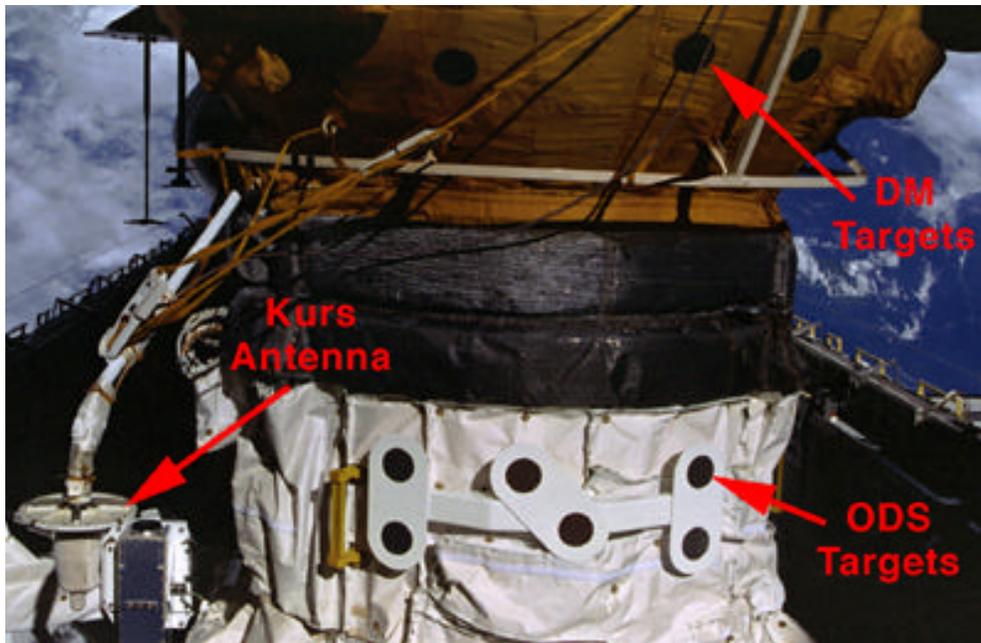
**Figure 8.1 Kurs Antenna as seen from the Shuttle Flight Deck on STS-84**

Between STS-79 and STS-81, a Kurs antenna was attached to the Mir Docking Module. This Kurs antenna extends toward the Shuttle forward bulkhead as shown in Figure 8.1. The JSC Structures and Mechanics Division (SMD) requested that an analysis be performed to determine the position of the tip of the antenna from STS-81, STS-84, and STS-86 imagery. This position information will assist SMD in determining the clearances between the antenna and the Shuttle Payload Bay forward bulkhead. The STS-81 and STS-84 results were included in references 6 and 7. The following describes the STS-86 analysis and results.

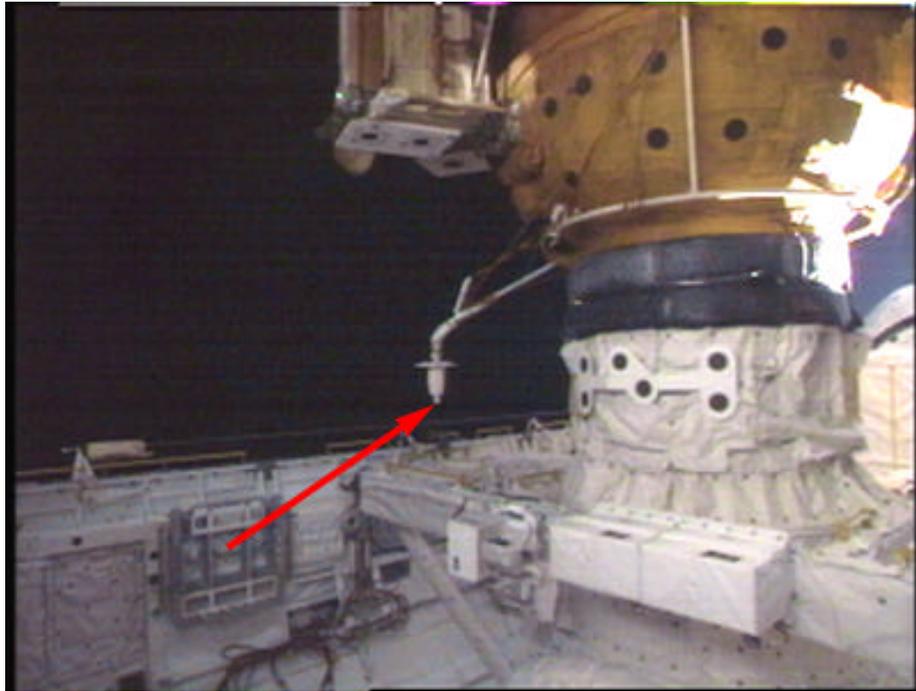
**Figure 8.2 Kurs Antenna as seen from Payload Bay Camera A**

Standard photogrammetric techniques were used to determine the location of the Kurs antenna. The same techniques were used for the STS-81, STS-84, and STS-86 analyses. Two overlapping video images of the antenna were used to perform a 3-dimensional triangulation to determine the position of the tip of the antenna in the Shuttle Structural Coordinate System (SSCS). The ODS targets and the Docking Module targets of the Orbiter Space Vision System (OSVS), shown in Figure 8.1, were used to establish the camera pointing angles for the two STS-86 video images used in the analysis. These two images from Shuttle PLB Cameras A and D are shown as Figures 8.2 and 8.3 respectively.

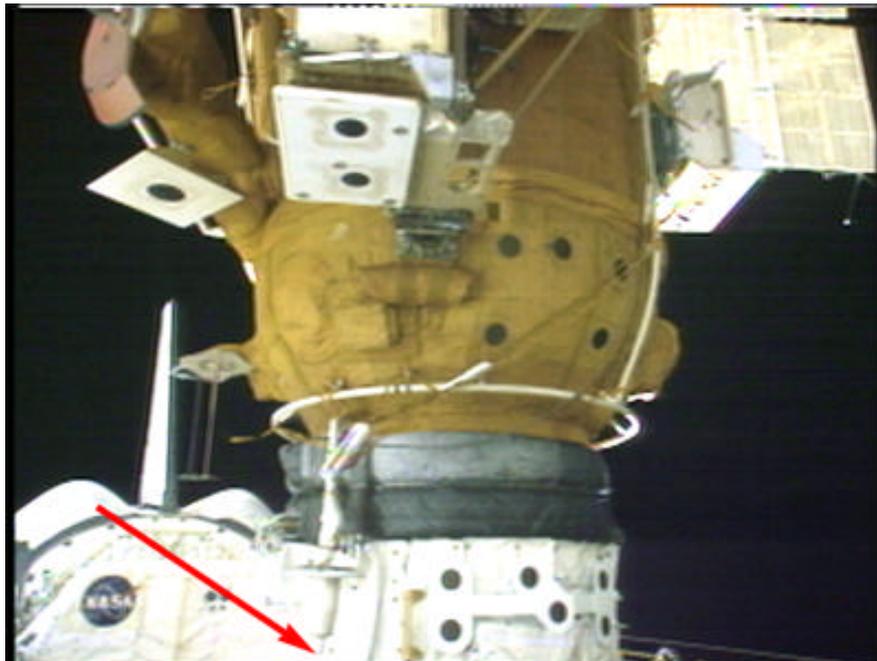
**Figure 8.3 Kurs Antenna as seen from Payload Bay Camera D**

The results from the STS-86 analysis are given in Table 8-1. The STS-81 results, the STS-84 results, and the expected coordinates based on data obtained from the Space Shuttle Program Integration Engineering Office are also in the table. The estimated positions from STS-81, STS-84, and STS-86 analyses are accompanied by an uncertainty estimate derived from a standard Monte Carlo error estimator. The STS-86 results indicate a clearance of 109.8 inches between the tip of the antenna and the Shuttle forward bulkhead. The STS-81 and STS-84 clearances were calculated to be 109.4 and 109.6 inches respectively.

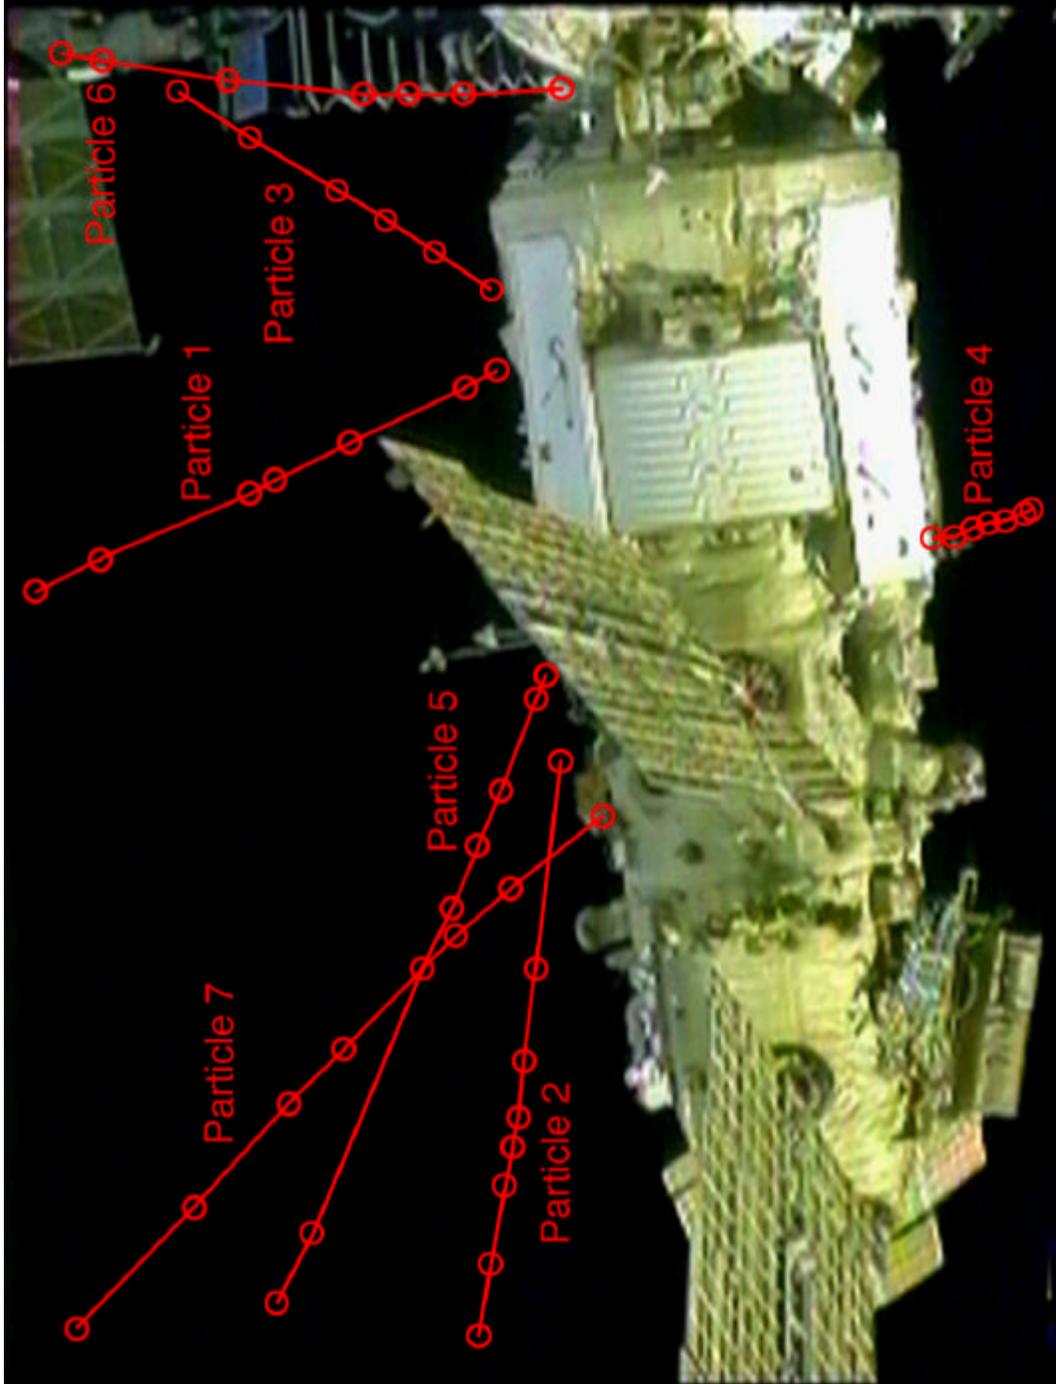
Figure 9. Composite of Particle Trajectories from CTVC (Camera D) View During Flyaround

A composite of the trajectories of the seven particles is shown in Figure 9. The uneven spacing of the interstitial points is a result of only choosing the brightest points in each particles trajectory for digitization. Particles one, two, three and five appear to originate from areas midway between the SP #1 attach and the junction of the module at the docking node. Particle four appears to originate from a region near the edge of the damaged thermal control system radiator panel farthest from the docking node. Particle six appears to originate from an area near the junction with the node. Particle seven appears to originate from a region stretching from the edge of the damaged thermal control system radiator panel farthest from the docking node to the scientific airlock on the -XB side of Spektr. It should be noted that this region encompasses the Spektr SP#1 attach point.

proximity to the Orbiter. The debris noted in this report was seen within two minutes after the first gas release, and no debris was observed at any other time during the daylight portion of the fly-around (undocking and backaway for the fly-around occurred during a night pass). In addition, all of the observed particles are seen moving away from the module and never toward it, implying that they originate from somewhere on the surface of the module. Therefore, it is unlikely that these particles are randomly observed debris, but are, indeed, the result of the gas released within Spektr.
